NCC Building Inspection

20220916-18267581999

**Address** 24 Sussex Drive, Main Residence

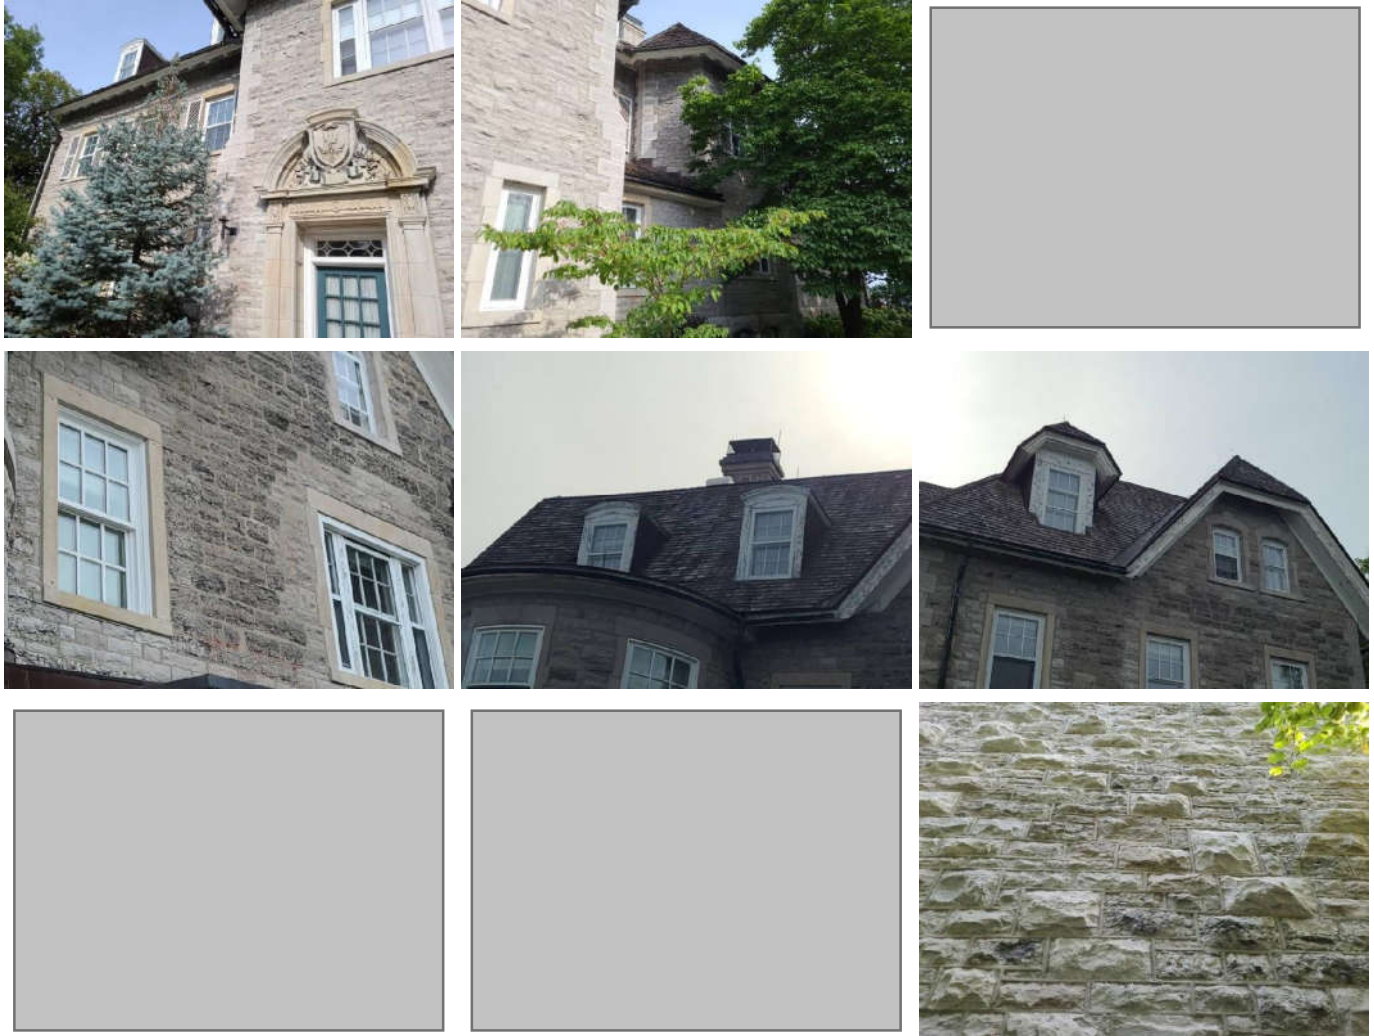
<b>Architectural Elements</b>	Poor
<b>Ext. Walls - Veneer / Siding</b>	Poor
<b>Remaining Envelope Life</b>	0-5 years
<b>Comment on areas of concern (Envelope)</b>	Sections of spalling stone and cracking.
<b>Photos</b>

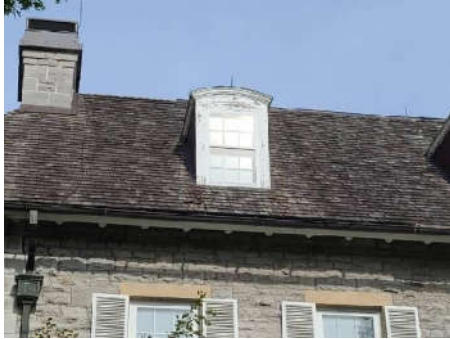
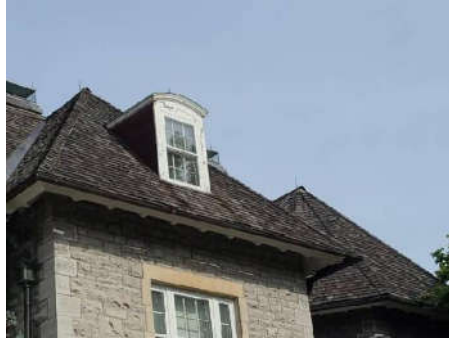
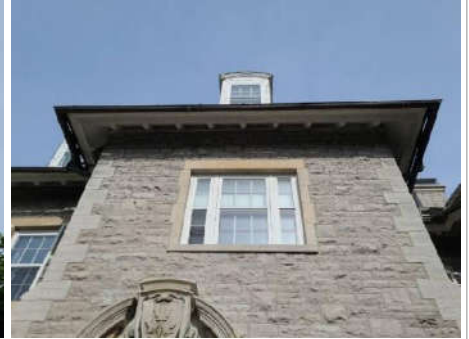
<b>Cladding Type</b>	Cedar
<b>Cladding</b>	Critical
<b>Cladding Comments</b>	Some asphalt and metal sections.
<b>Flashing / Vents</b>	Critical
<b>Fascia / Soffit</b>	Poor
<b>Fascia / Soffit Comments</b>	Paint required.
<b>Gutters / Ice Bars</b>	Critical

Gutters are too far from the roof line, they do not catch water and form icicles during winter. Gutters could possibly be detaching from fascia, creating a fall hazard.

Areas inside show evidence of leaks from the roof.

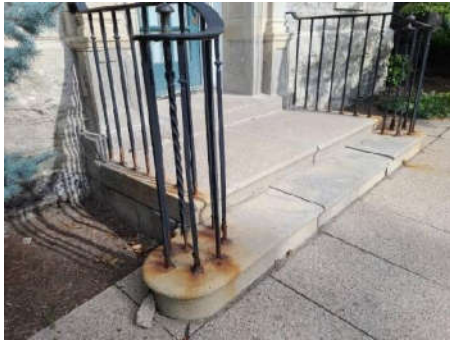
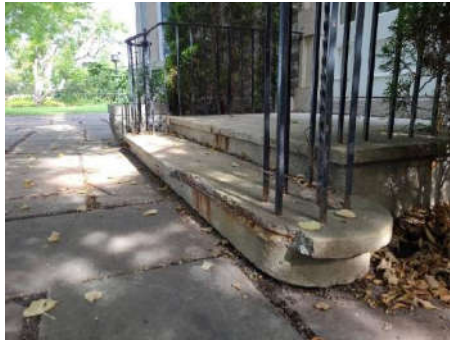
<b>Building / Structures</b>	Poor
<b>Stairs / Railings</b>	Critical
<b>Stairs / Railings Comments</b>	Exterior rails and steps have deteriorated significantly.
<b>Remaining Structures Life</b>	0-5 years
<b>Comment on areas of concern (Structures)</b>	Structural repairs in rafters seem to be stable.  Interior stair rails are not to code.
