NCC Building Inspection

20220916-18267581999

**Address** 24 Sussex Drive, Main Residence

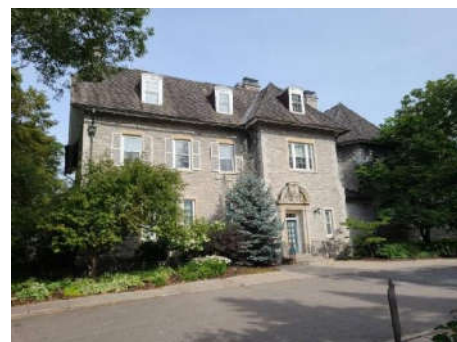
**Inspection Comments** The building systems have reached the point of imminent or actual failure and require replacement. The age and condition of the electrical systems poses a fire hazard and the plumbing systems have failures on a regular basis. The building has no permanent air conditioning system; window air conditioners are run in every room in the summer. Repairs and/or upgrades are complicated due to the presence of asbestos, lead and mould throughout most of the interior finishes. Due to the condition of the building, the building is unoccupied since 2015.
