Official Residences of Canada

2021 ASSET PORTFOLIO CONDITION REPORT

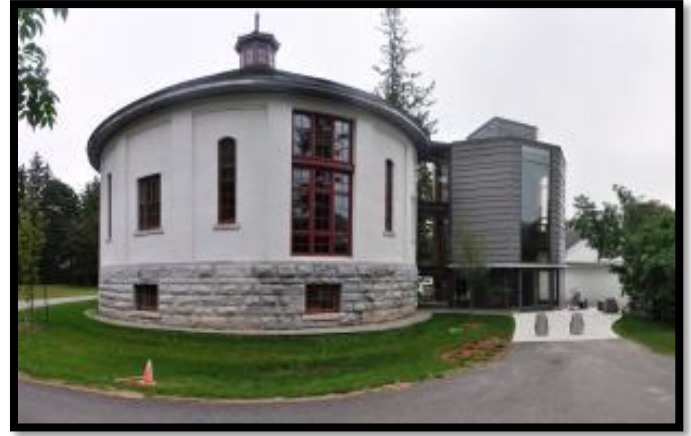
3.1.2.5 The Dome Building

Originally a “gasometer” built in 1877–78 to store manufactured coal gas to fuel light fixtures in the residence, it was rehabilitated in 2013. The rehabilitation included a three-floor elevator tower and extensive designated substances removal. It is currently used for OSGG administrative functions.
