NATIONAL CAPITAL COMMISSION
COMMISSION DE LA CAPITALE NATIONALE

Official Residences of Canada

ASSET PORTFOLIO CONDITION REPORT

APRIL 2018 (FINAL)

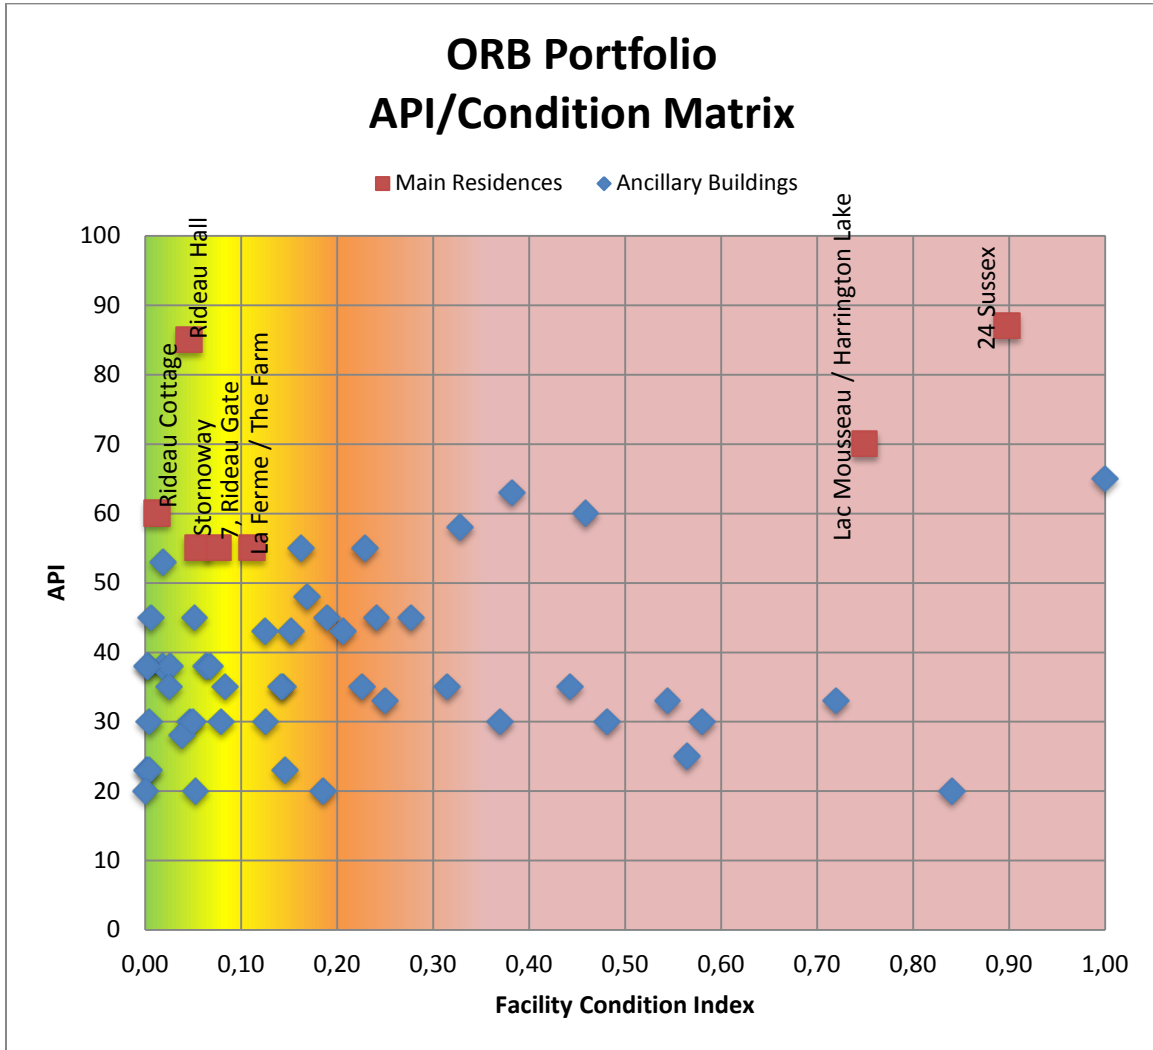
Figure 6: OR API/FCI Matrix

A comparison of the API and FCI of the ORBs portfolio is shown graphically below.

Figure 6 demonstrates that both 24 Sussex and Harrington Lake along with the Caretaker's Cottage are in critical condition and a high priority.

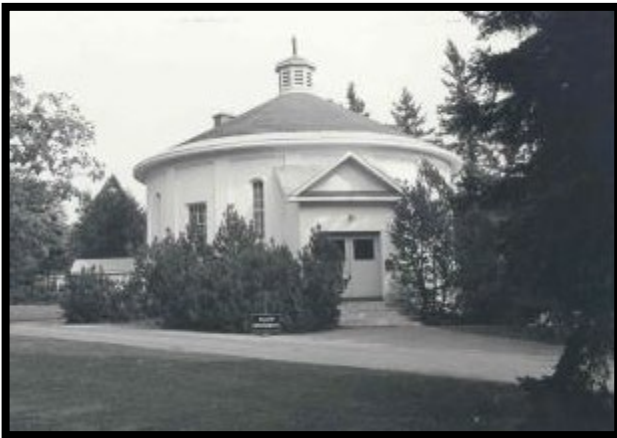
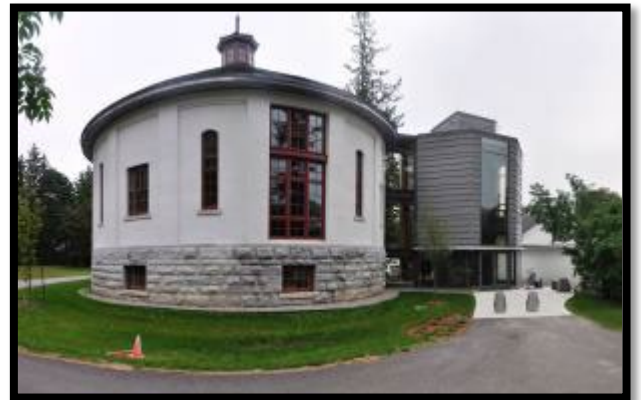
4.1.2.5 The Dome Building

Originally a “gasometer” built in 1877-78 to store manufactured coal gas to fuel light fixtures in the residence, it was rehabilitated in 2013. The rehabilitation included a 3-floor elevator tower and extensive designated substances removal. It is currently used for OSGG administrative functions.
