NATIONAL CAPITAL COMMISSION  
COMMISSION DE LA CAPITALE NATIONALE

- Official Residences of Canada Asset Portfolio Condition Report 2021

- To provide an update to the Board of Directors on the state of the building assets in the Official Residences Portfolio, based on a thorough building condition review, summarized in the 2021 Asset Condition Report.

## 2021 ASSET PORTFOLIO CONDITION REPORT

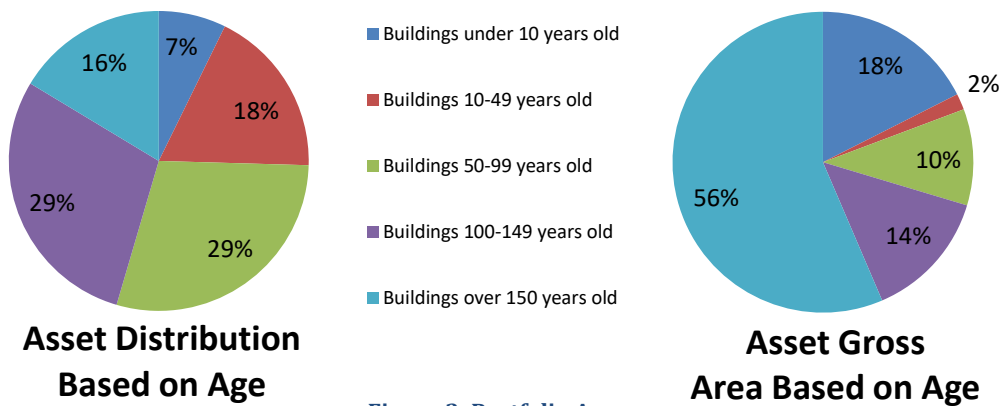
Figure 3: Portfolio Age

The main residences and the overwhelming majority of their ancillary buildings were built when different building codes and lower standards of health and safety requirements applied. Approximately 74% of the building portfolio is over 50 years old, with 16% older than Canada, which recently celebrated its 150<sup>th</sup> birthday in 2017.

As shown in Figure 3, 74% of the building portfolio is over 50 years old.

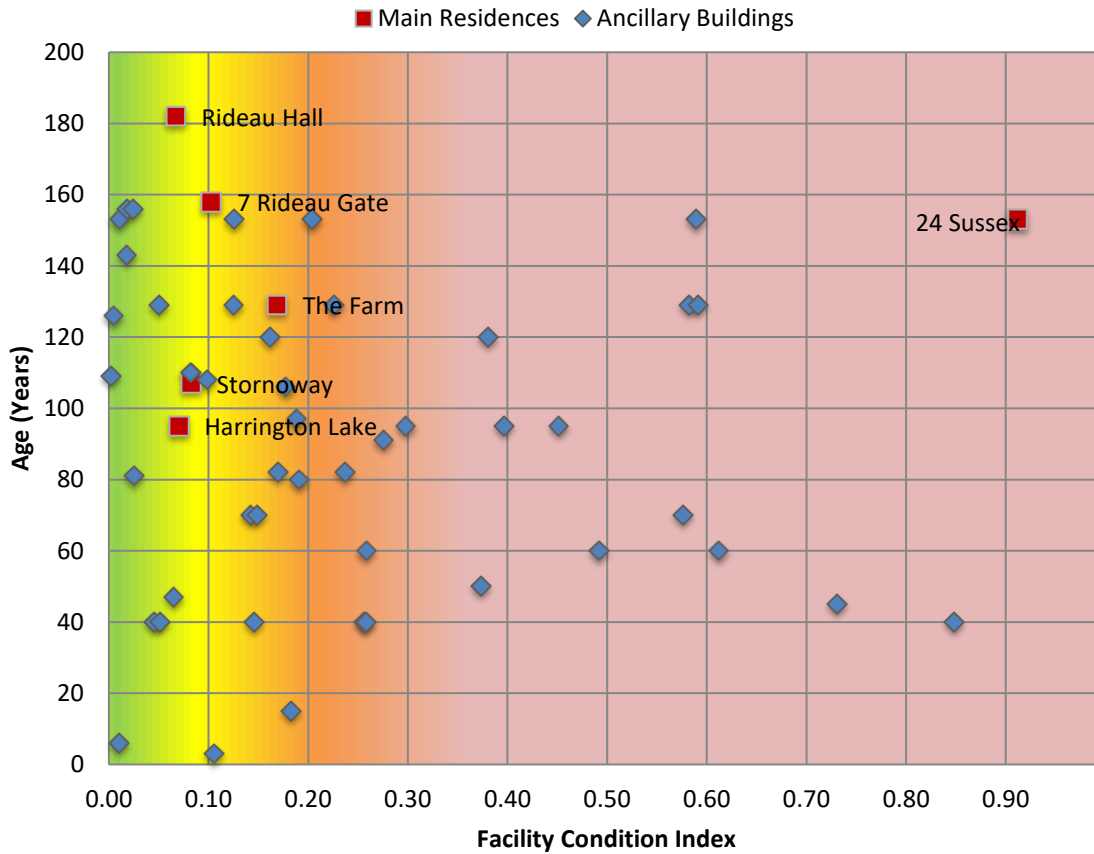
Figure 5: OR Portfolio Age/FCI Matrix

Official Residences Portfolio  
Age/Facility Condition Index Matrix

Figures 4 and 5 demonstrate that while the overall FCI for the Portfolio is “Poor” at 0.136, 61% of the Portfolio’s individual assets are identified as being in “Poor” to “Critical” condition. However, the vast majority of the assets are operationally safe. Of the main residences, Rideau Hall, Harrington Lake, Stornoway and 7 Rideau Gate are now all in “Fair” condition, with the Farm in “Poor” leaving only 24 Sussex “Critical”. Historical investments have been prioritized to repair building failures (roof leaks, plumbing, electrical, etc.), alleviate current health and safety concerns, comply with regulations and ensure critical building systems remain in operation.

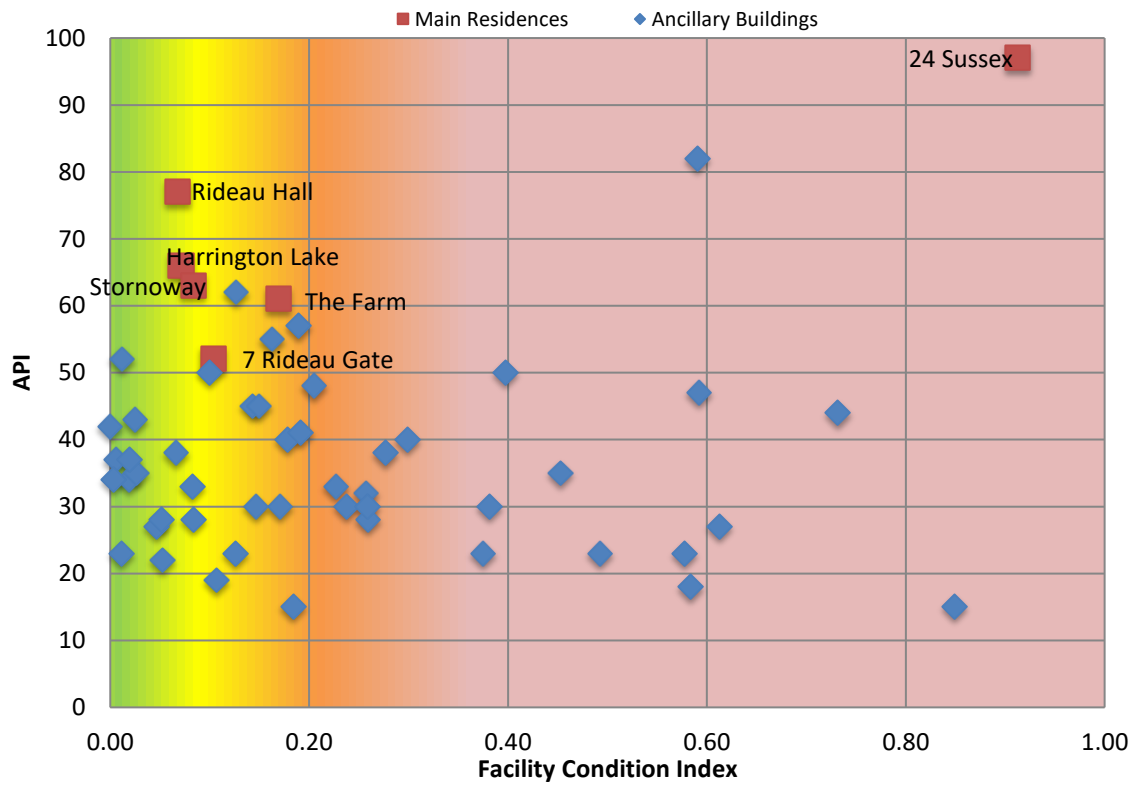
**Figure 6: OR API/FCI Matrix**

## ORB Portfolio API/Condition Matrix

Figure 6 demonstrates that 24 Sussex is in critical condition and a high priority.

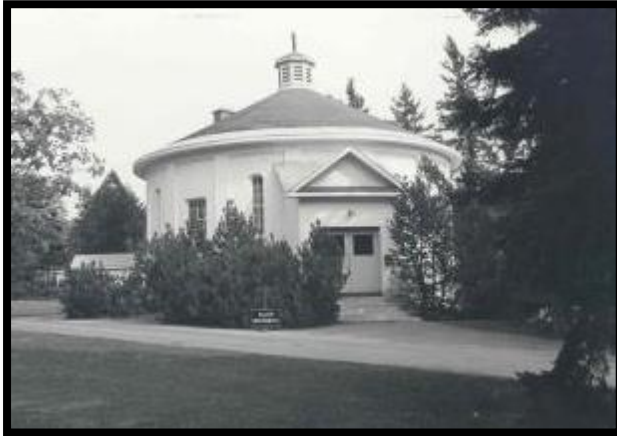
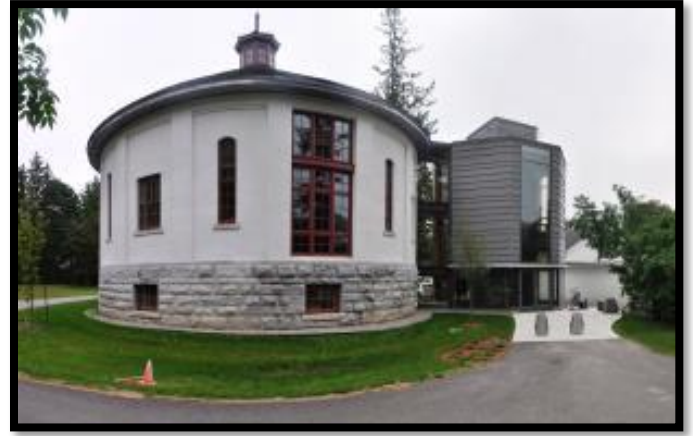
### ***3.1.2.5 The Dome Building***

Originally a “gasometer” built in 1877–78 to store manufactured coal gas to fuel light fixtures in the residence, it was rehabilitated in 2013. The rehabilitation included a three-floor elevator tower and extensive designated substances removal. It is currently used for OSGG administrative functions.
