NATIONAL CAPITAL COMMISSION
COMMISSION DE LA CAPITALE NATIONALE

Official Residences of Canada

ASSET PORTFOLIO CONDITION REPORT

APRIL 2018 (FINAL)

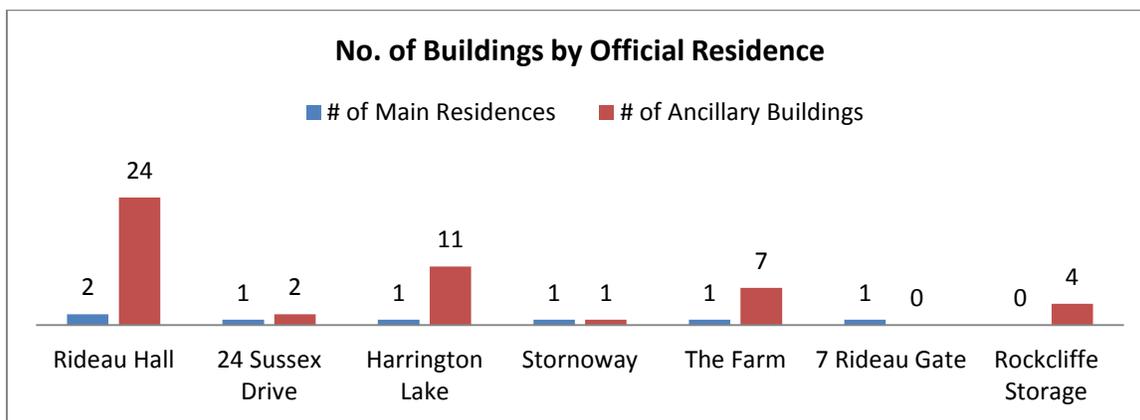
Figure 2: No. of Official Residence Buildings

The Official Residences Branch (ORB) is responsible for the property management activities, as well as long-term planning and capital improvements for the six-property, 56-building portfolio². Note that four of the buildings that the ORB maintains are located at a remote site, and used for storage of materials. The breakdown of the portfolio by official residence is shown below.

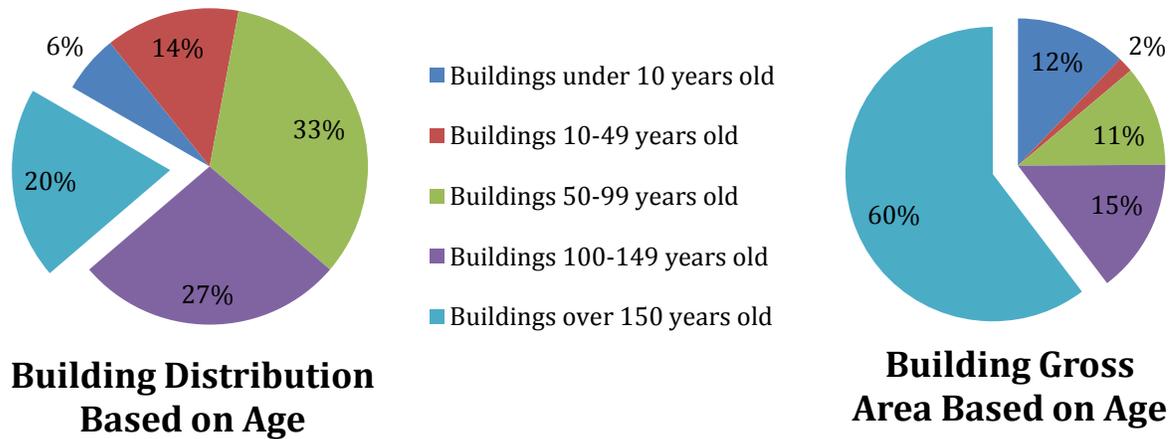
Figure 3: Portfolio Age

The main residences and the overwhelming majority of their ancillary buildings were built when different building codes and lower standards of health and safety requirements applied. Approximately 80% of the building portfolio is greater than 50 years old, with 20% older than Canada, which recently celebrated its 150th birthday.

As shown in Figure 3, 80% of the building portfolio is greater than 50 years old.

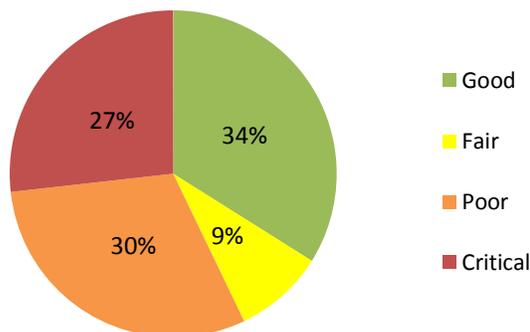
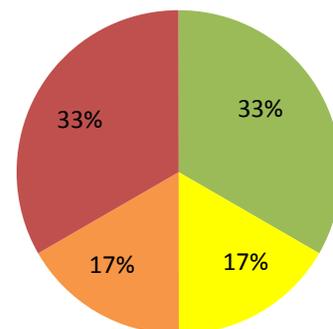
Figure 4: OR Portfolio FCI Assessment

Based on the 2017 BCR estimation of deferred maintenance and an estimated CRV of \$615M – the overall FCI of the portfolio is 0.134 – which translates into an overall assessment of “Poor”.

**ORB Building Portfolio
 FCI Based on No. of Buildings**

**ORB Main Residences
 FCI Based on No. of Buildings**

Figures 4 and 5 demonstrate that while the overall FCI for the portfolio is in “POOR” condition at 0.134, 58% of ORB’s individual assets are identified as being in ‘POOR’ to ‘CRITICAL’ condition and 50% of the main residences are ‘POOR’ to “CRITICAL’. However, the assets are operationally safe. Historical investments have been prioritized to alleviate current health and safety concerns, comply with regulations, ensure critical building systems remain in operation, and to address occupant priorities.

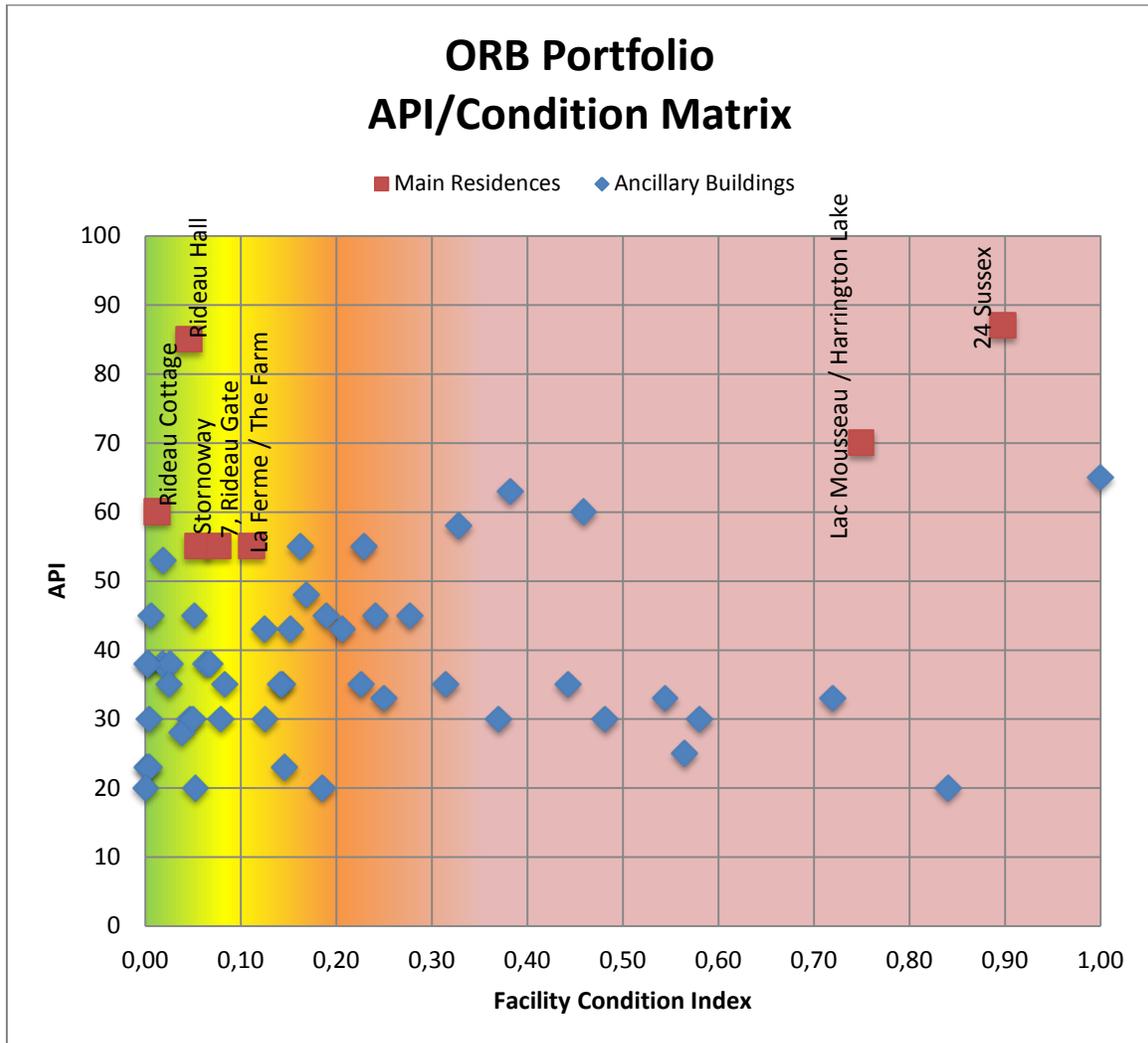
Figure 6: OR API/FCI Matrix

A comparison of the API and FCI of the ORBs portfolio is shown graphically below.

Figure 6 demonstrates that both 24 Sussex and Harrington Lake along with the Caretaker's Cottage are in critical condition and a high priority.

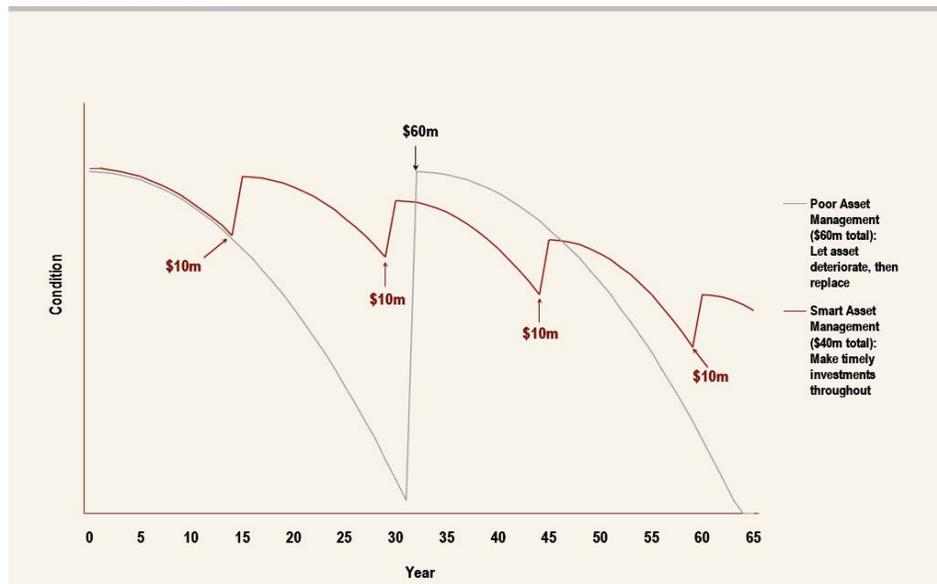
As annual investments in this order of magnitude have not been available for the Official Residences portfolio, many assets have deteriorated faster than life cycle forecasts would predict and now require complete recapitalization. The following figure highlights the benefits of timely renewal investments:

Figure 7: Small but Timely Renewal Investments Save Money (<https://www.ontario.ca/page/building-together-guide-municipal-asset-management-plans#f1>)

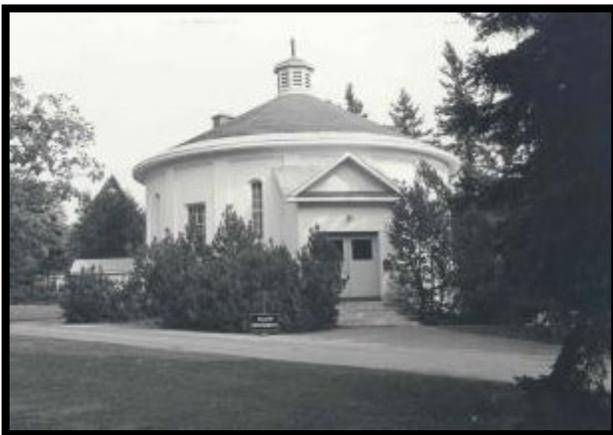
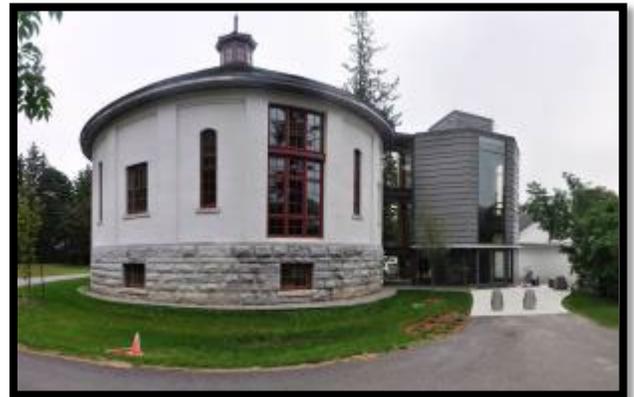
4.1.2.5 The Dome Building

Originally a “gasometer” built in 1877-78 to store manufactured coal gas to fuel light fixtures in the residence, it was rehabilitated in 2013. The rehabilitation included a 3-floor elevator tower and extensive designated substances removal. It is currently used for OSGG administrative functions.

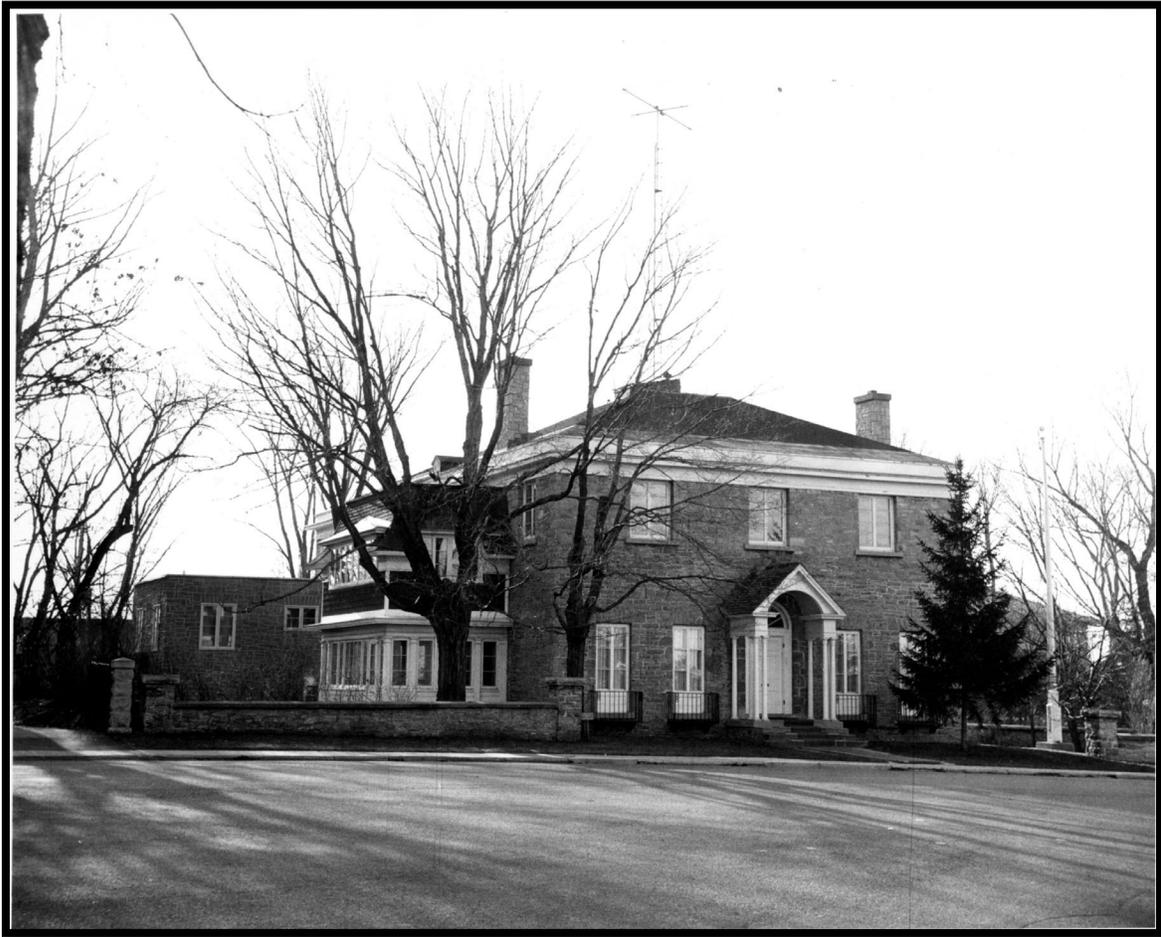
Designed by architect Alan Keefer, this 790 square-meter private home was built in 1862 and was obtained by the Crown in 1966 as lodgings for visiting dignitaries who are guests of Canada. The Victorian architecture home was restored and renovated in 1989 to reinstate historical features as well as to upgrade the guest facilities.

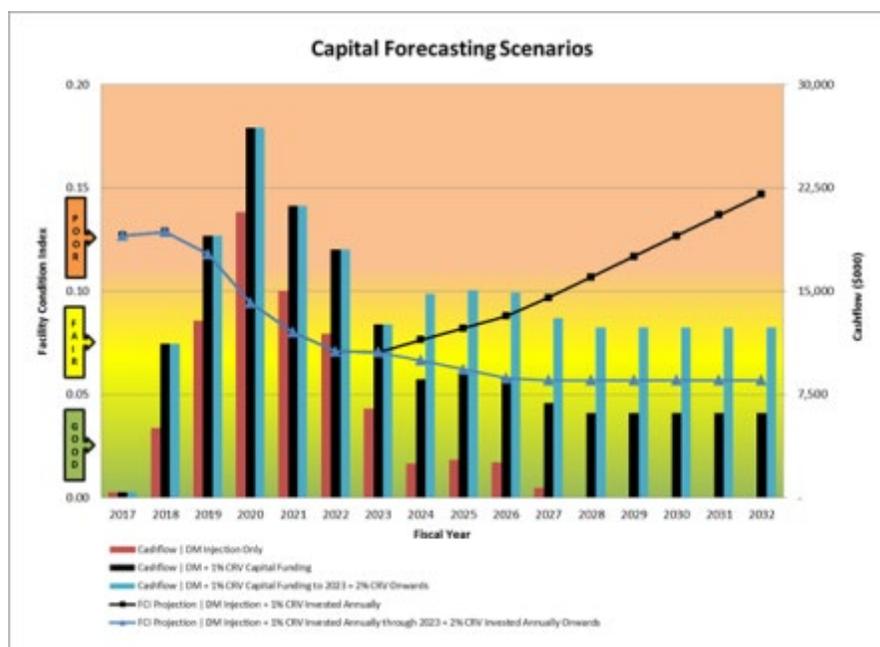
Figure 8: Capital Forecast Scenarios

Without sustainable funding, the deferred maintenance deficit will continue to grow and more assets will resemble 24 Sussex. As demonstrated in the figure below, even with a one-time injection (\$83M and current funding levels (~1% CRV = \$6M), FCI will deteriorate to “Poor” in 10 years. With a one-time injection (\$83M) and on-going funding ~2% CRV = \$12 M/yr), FCI can be maintained between “Fair” and “Good”. In other words, an increase in annual capital appropriations of \$12.3 million would provide a sustainable source of funds that could be used to conserve the built heritage of national interest under the NCC’s stewardship.

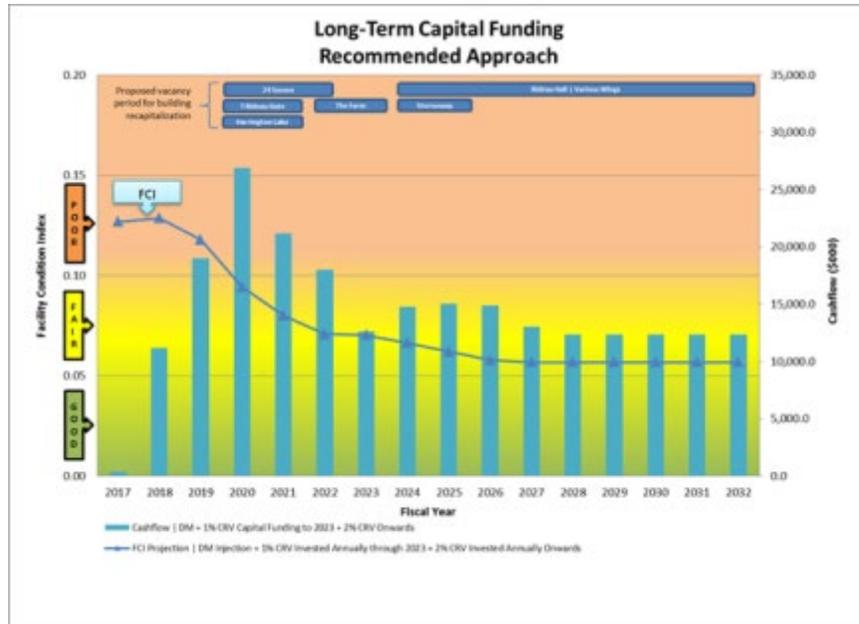
Figure 9: Long-Term Capital Plan Recommended Approach

However, funding is not the only requirement. Predictable access to funding (a one-time injection and increased annual capital appropriations) is another key element, as highlighted in the figure below.

Without both a sustainable source of funds and access to the residences to undertake regular repair, maintenance and scheduled capital improvements, the NCC will not be able to fulfill its mandate with respect to the official residences. The NCC's recommended approach: a long-term Capital Plan published annually identifying timing and duration of Official Residences projects would be open and transparent and would maintain the portfolio in "fair – good" condition.
